L1358070001 – Montgomery
Eagle Zinc Company
ILD 980606941
SF/HRS

Expanded Site Inspection

CERCLA Expanded Site Inspection Report
for

Eagle Zinc Company

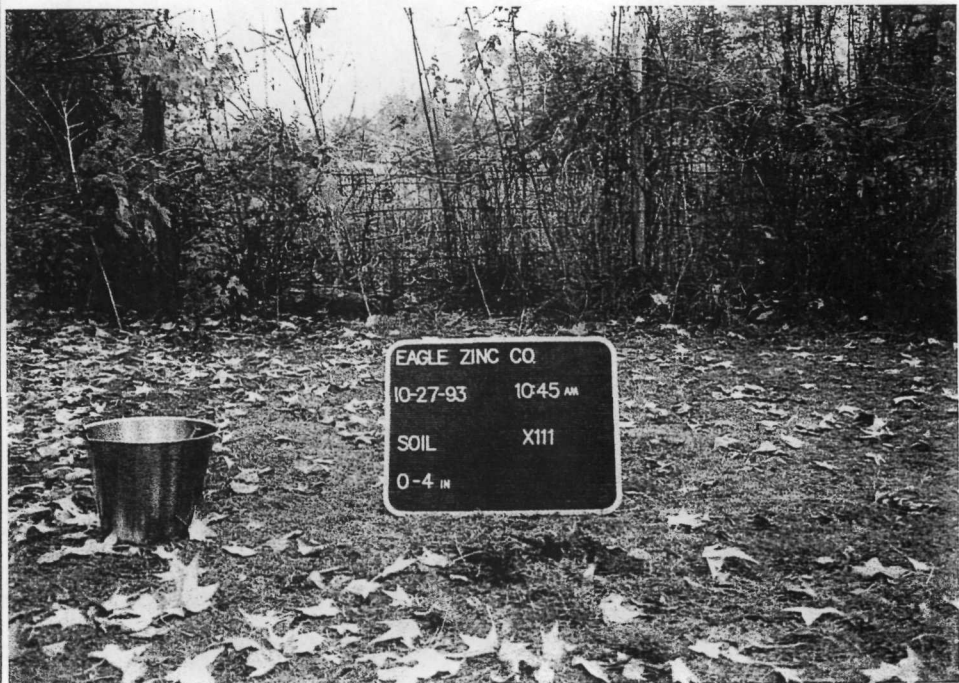
DATE: 10/27/93
TIME: 10:45 A
PHOTOGRAPH TAKEN BY: MARK WAGNER
COMMENTS: Picture taken toward: NORTH
Sample X111
Residential soil sample.
Depth 0-4 in
Roll 4, Photo 6

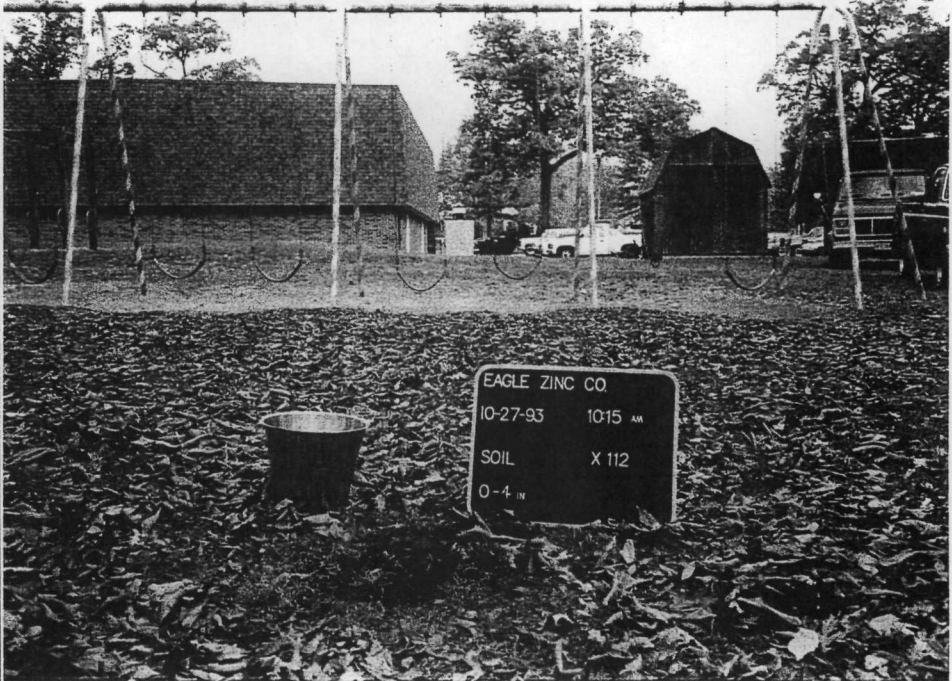
COMMENTS: Picture taken toward: NORTH	
Sample X112	
Soil sample at	
Beckmeyer Grade	
School on Fair-ground Street.	
Depth 0-4 in	
Roll 4, Photo 3

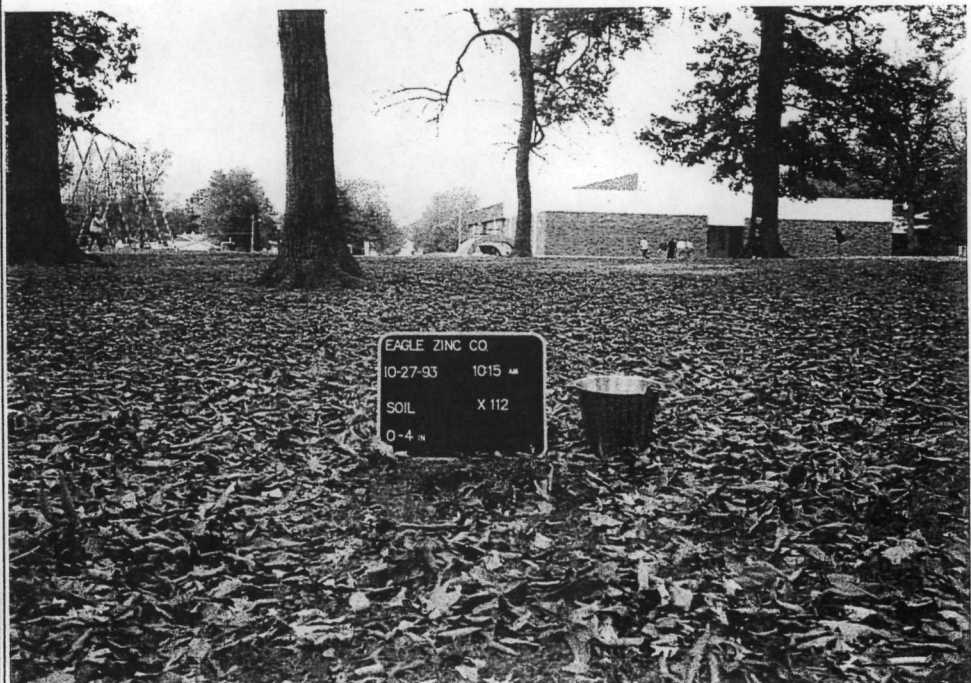
DATE: 10/27/93
TIME: 10:15 A
PHOTOGRAPH TAKEN BY: MARK WAGNER
COMMENTS: Picture taken toward: WEST
Sample X112
Soil sample at
Beckmeyer Grade
School on Fair-ground Street.
Depth 0-4 in
Roll 4, Photo 4

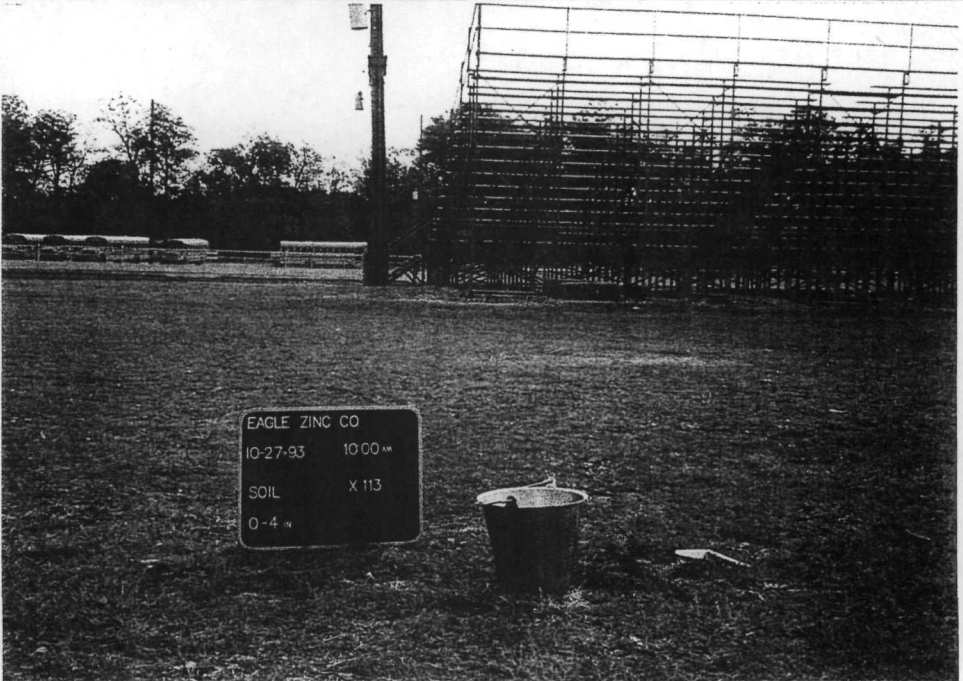
COMMENTS: Picture taken toward: EAST	
Sample X113	
Soil sample taken from Hillsboro High School baseball outfield.	
Depth 0-4 in	
Roll 4, Photo 1

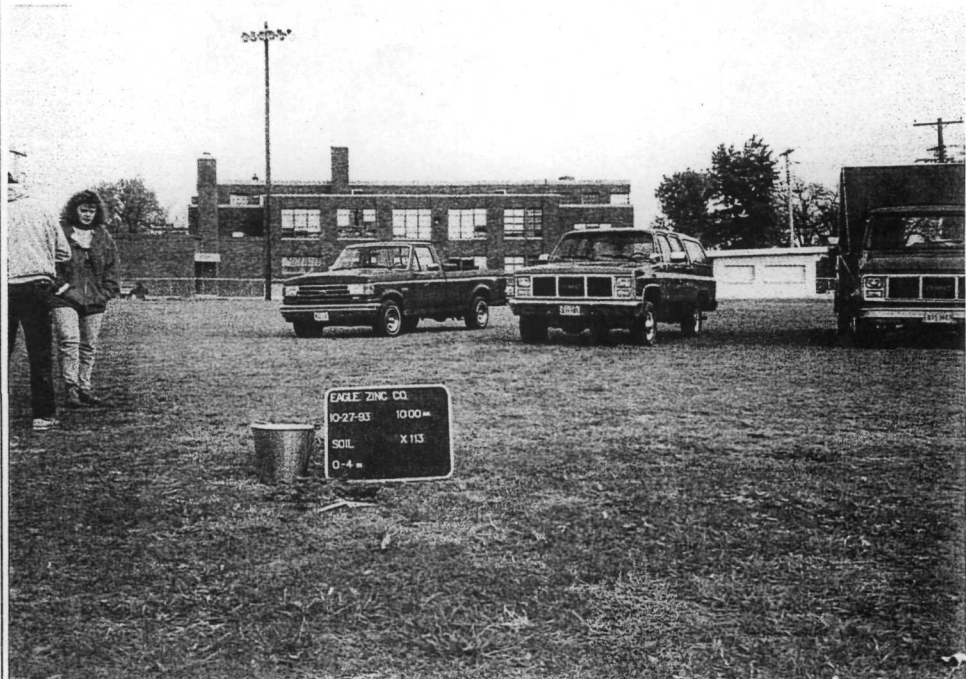
DATE: 10/27/93
TIME: 10:00 A
PHOTOGRAPH TAKEN BY: MARK WAGNER
COMMENTS: Picture taken toward: NORTH
Sample X113
Soil sample from baseball outfield with Hillsboro High school in backgrd.
Depth 0-4 in
Roll 4, Photo 2

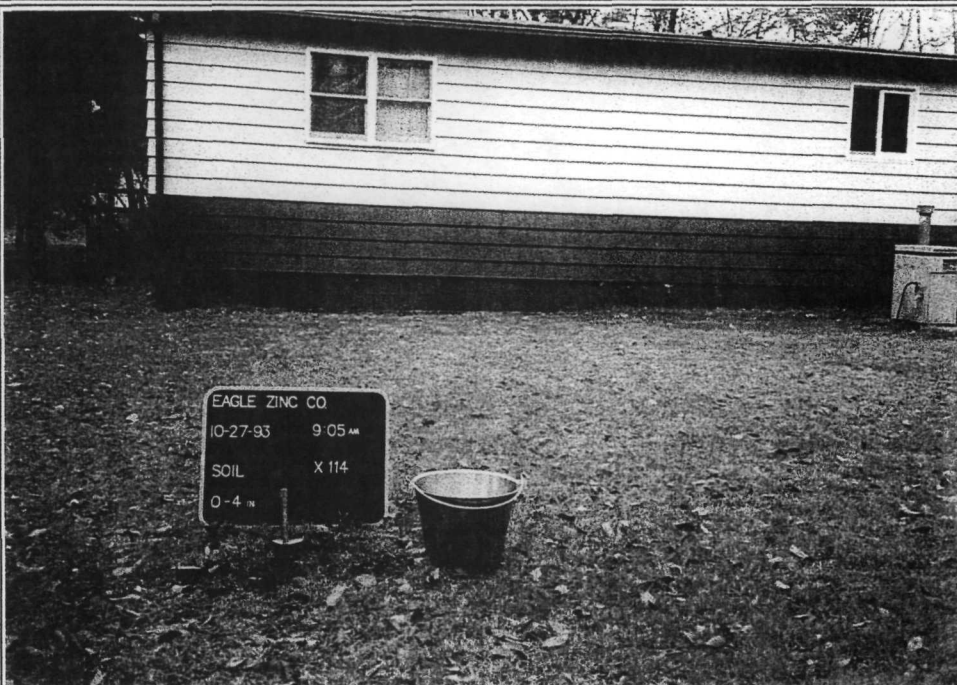
COMMENTS: Picture taken toward: WEST	
Sample X114	
Residential soil sample.	
Depth 0-4 in	
Roll 3, Photo 11

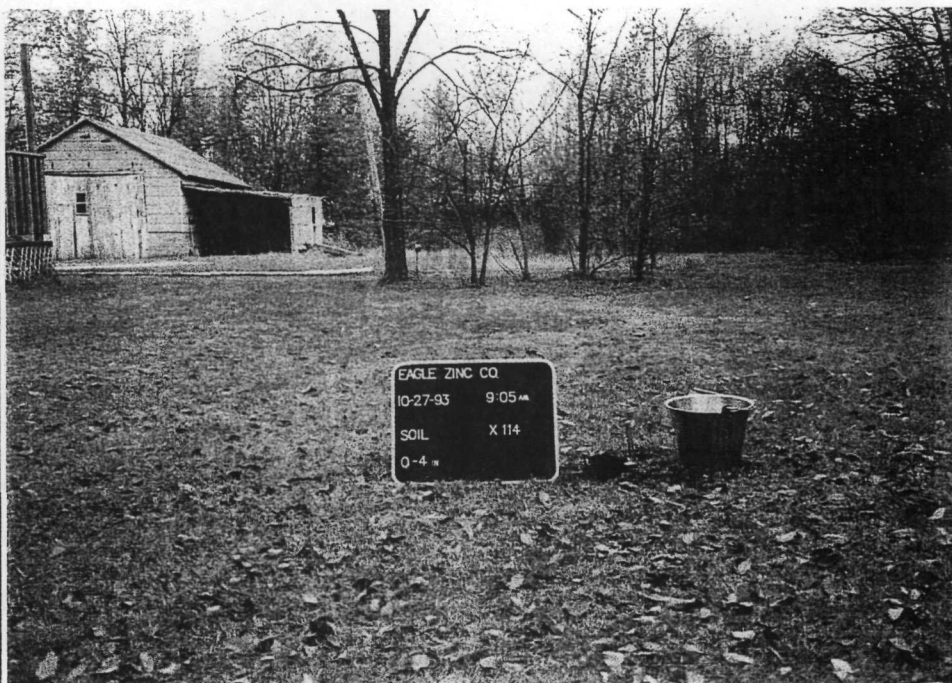
DATE: 10/27/93
TIME: 9:05 A
PHOTOGRAPH TAKEN BY: MARK WAGNER
COMMENTS: Picture taken toward: NORTH
Sample X114
Residential soil samples.
Depth 0-4 in
Roll 3, Photo 12

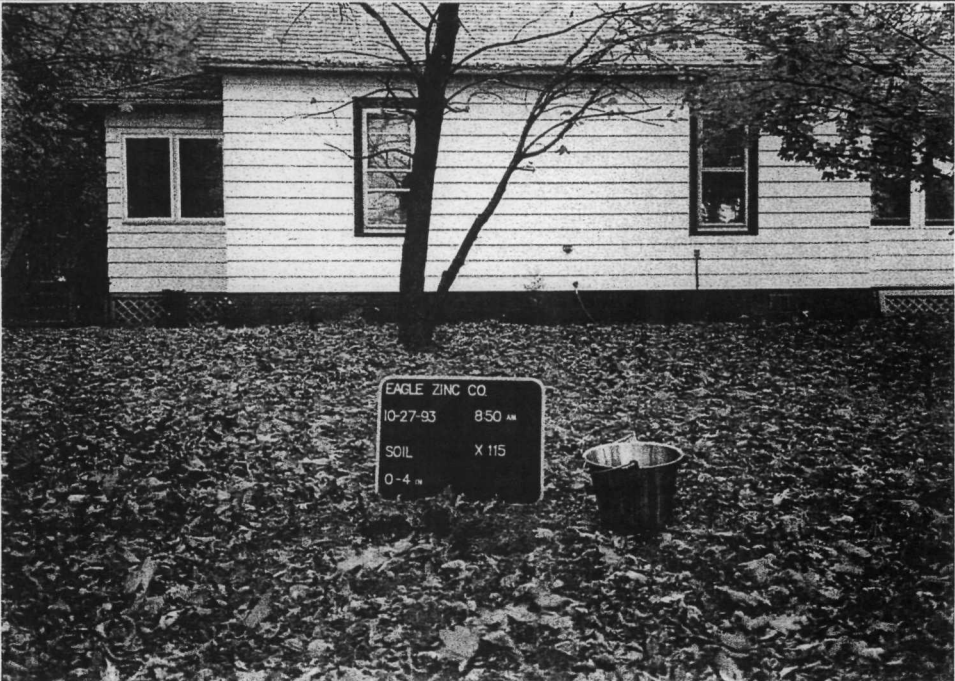
COMMENTS: Picture taken toward: NORTH	
Sample X115	
Residential soil sample.	
Depth 0-4 in	
Roll 3, Photo 9

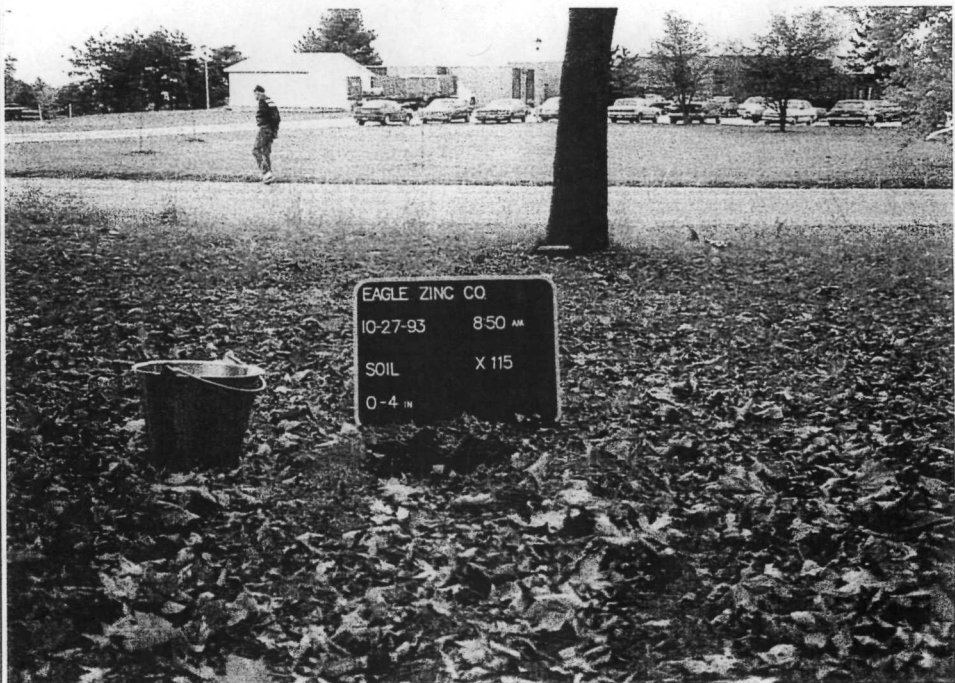
DATE: 10/27/93
TIME: 8:50 A
PHOTOGRAPH TAKEN BY: MARK WAGNER
COMMENTS: Picture taken toward: SOUTH
Sample X115
Residential soil sample.
Depth 0-4 in
Roll 3, Photo 10

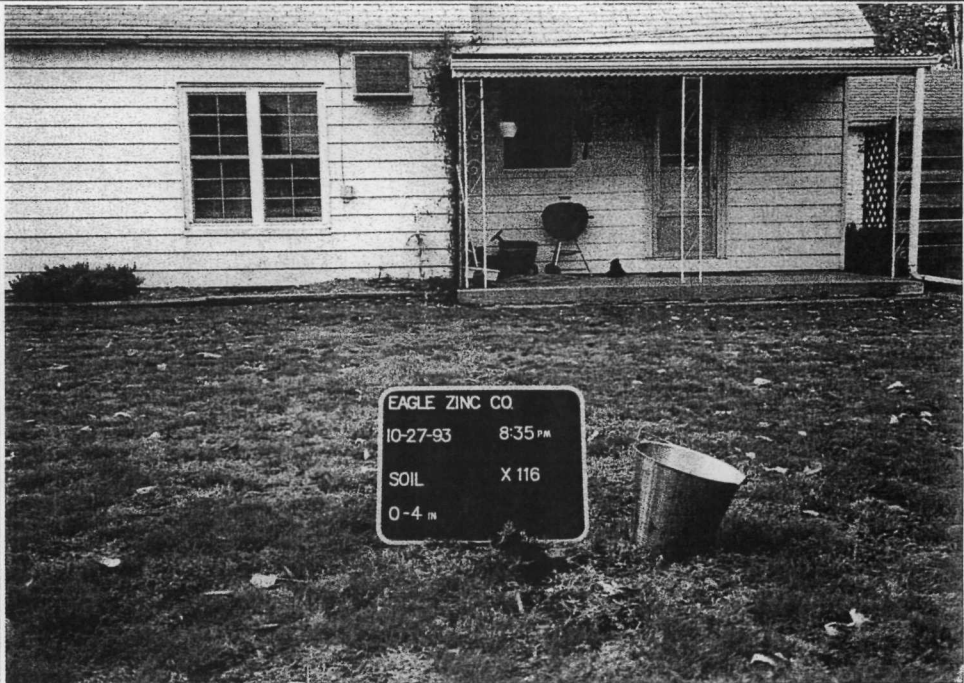
COMMENTS: Picture taken toward: SOUTH	
Sample X116	
Residential soil sample.	
(Photo should have read AM) .	
Depth 0-4 in	
Roll 3, Photo 7

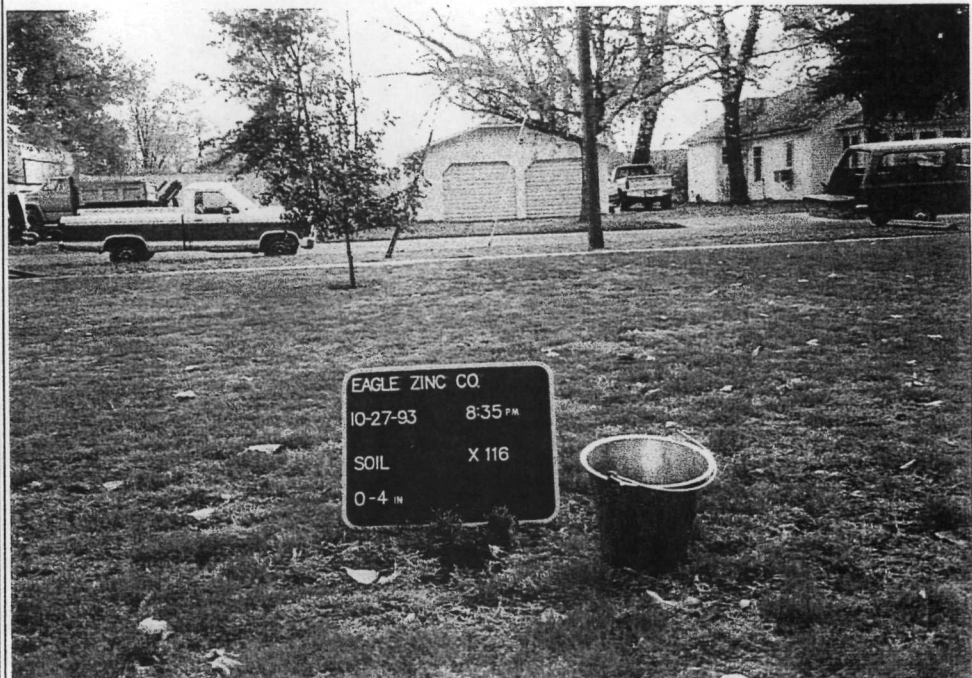
DATE: 10/27/93
TIME: 8:35 A
PHOTOGRAPH TAKEN BY: MARK WAGNER
COMMENTS: Picture taken toward: EAST
Sample X116
Residential soil sample.
(Photo should have read AM) .
Depth 0-4 in
Roll 3, Photo 8

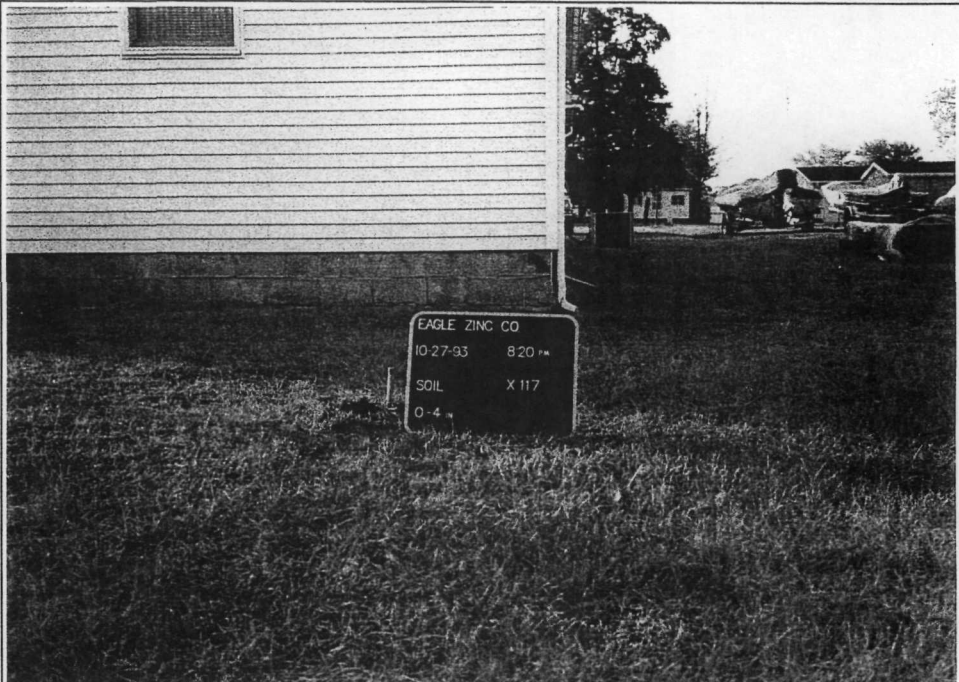
COMMENTS: Picture taken toward: SOUTH	
Sample X117	
Residential soil sample.	
(Photo should have read AM) .	
Depth 0-4 in	
Roll 3, Photo 5

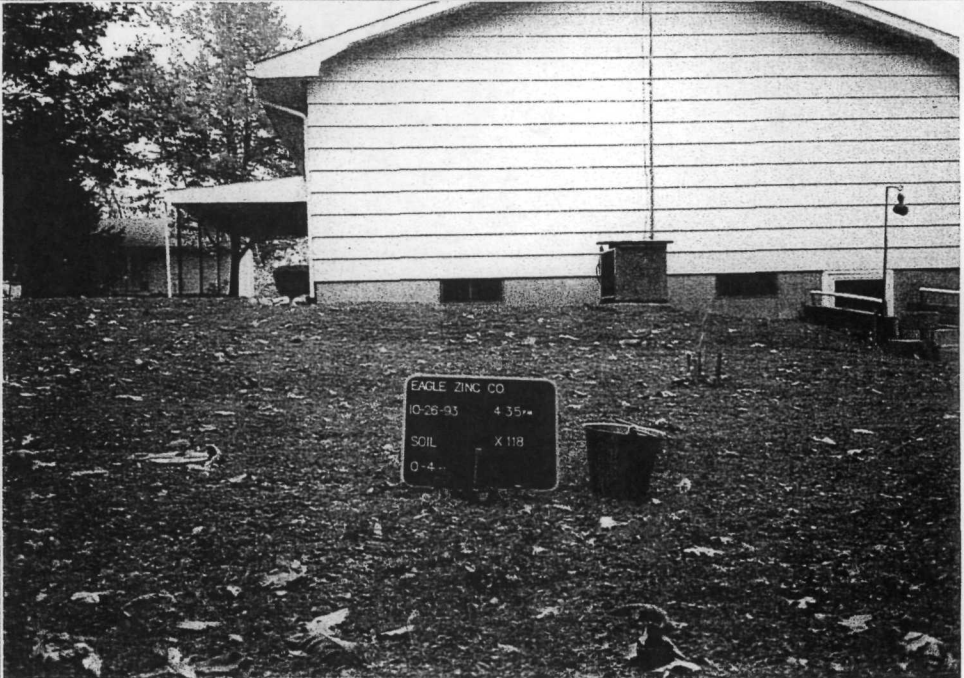
COMMENTS: Picture taken toward: NORTH	
Sample X118	
Residential soil sample.	
Depth 0-4 in	
Roll 2, Photo 11
